LIGHTWEIGHT STRUCTURES in CIVIL ENGINEERING

XXI LSCE –2015

Full-scale testing of steel lattice towers: requirements, preparation, execution, challenges, and the results

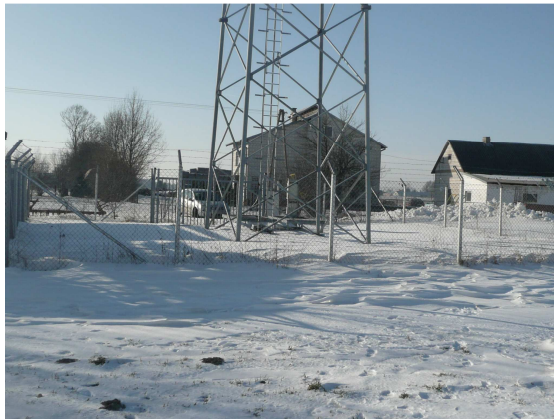
Fig. 1 Unfavorable location of the tower structure: close neighborhood of the buildings

One of the problems was the presence of transmission lines as well as building developments in the closest neighborhood (Figs 1-2). The insufficient free space around the objects posed direct threat to the citizens. The probability of unexpected damages rendered the research experiments impossible. The unfavorable location of the objects did not allow for external load to be utilized to the full extent either: usage of the heavy equipment generating the failure load required hard terrain and an empty space that would provide sufficiently large distance from the tested tower.

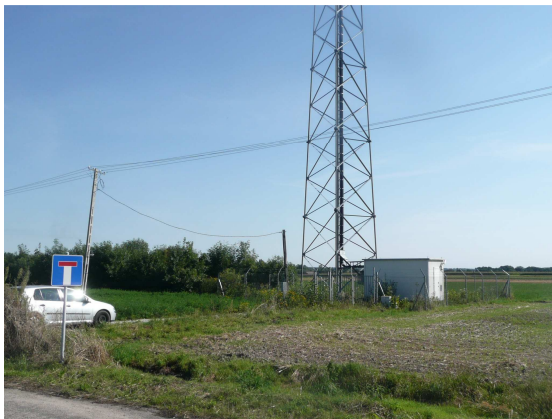
Fig. 2 Unfavorable location of the tower structure: close neighborhood of the medium voltage transmission lines

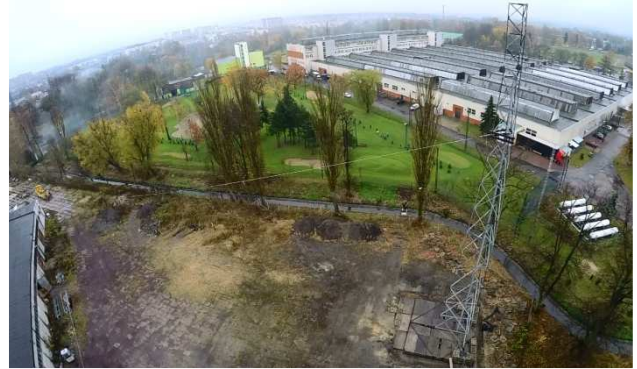
Fig. 3. Aerial view of the experimental site

Taking the aforementioned problems into consideration, the final decision was made to perform the research efforts at the specially accommodated place (documented by Fig. 3), which fulfilled all the requirements concerning geometric parameters and area, where the

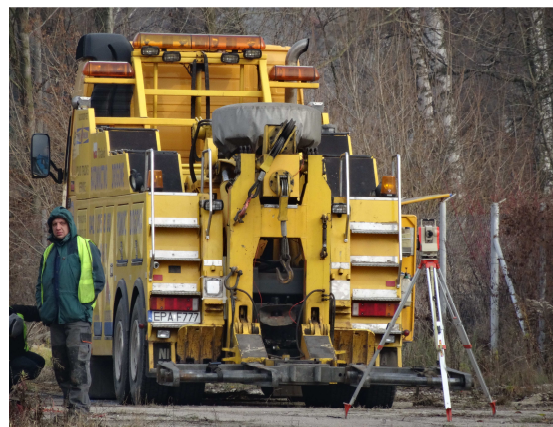
Fig. 5 Towing truck used in the experiments

A towing truck appeared to be an appropriate experimental device for this purpose (Fig. 5), which fulfilled the aforementioned criteria, had enough mass and could be anchored into the terrain, which guaranteed its stability against uncontrolled variations of normal stresses in the line. A special steel diaphragm was designed in order to allow for an appropriate transfer of the load to the entire cross-section rather than to a single joint or member (Figs. 6-7). The attachment location was selected to avoid the damage of the cantilever part of the tower (top section with the parallel legs) and to generate extreme forces in lower sections legs at the same time. The tower has been installed just before the experiments; therefore the welding of the diaphragm could be done before the structure got vertically fixed in the foundation, which simplified further the works.

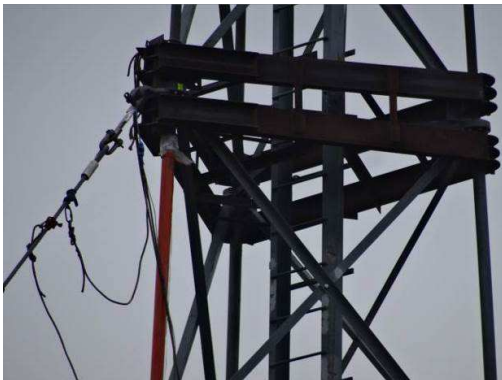
Fig. 7 Steel diaphragm during the experiment

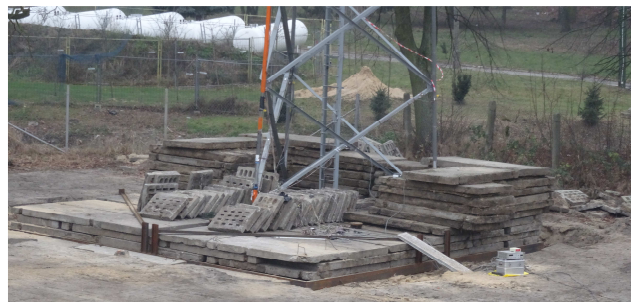
Fig. 10 Final foundation with asymmetric mass distribution

The elevation of foundations occurred during the testing of the second tower, which had the same geometry but larger element cross-sections than the first one - it took place for the total weight of about 110 tones. It is important to the future tests that such a mass was not sufficient to ensure perfect stability of the foundation itself. Therefore, the experiment was repeated after additional load was added to foundations, which resulted in the final weight of 170 tons.

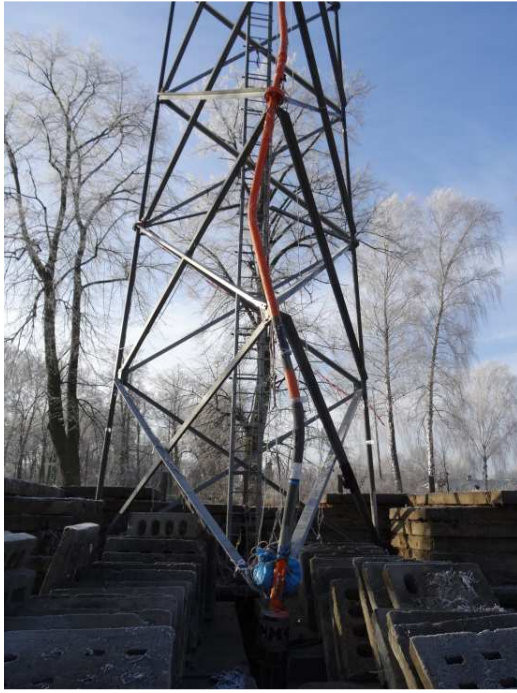
Due to the fact that the towers analyzed had different geometry, the cross sections of the legs, and also the diagonal bracing members, the final stability loss occurred at different heights and different sections. Exemplary failure mode of the second tested tower is depicted in Fig.16. The attached pictures show that the main extreme deformations occurred in the compressed leg at the section S-7 in case of the second tested tower.

Fig.16 Buckling of the tower leg in section S-7 (second tower)

The stability loss occurred in the section S-5 in the first case. For all cases, the buckling of the legs took place almost perpendicularly to the loading force. Plastic hinges occurred at the centers of the bracing panels, at 1/3 and 2/3 of section span. It should be noticed that the joints connecting the neighboring legs remained rigid due to significant thickness of the connecting flanges, and no so-called leverage effect was present. Taking damage schemes of the particular researched structures into consideration, it can be stated that the reliability of that structures is based on carrying capacity of the legs. The strength test of the real full-scale structures, whose particular elements are in real scale allows for authentic measurements of the large deformations. The advantage of those kinds of tests over the tests on laboratory models, which do not have real scale, is particularly visible in this case.
